# Instal·lació del Topspin 3.1

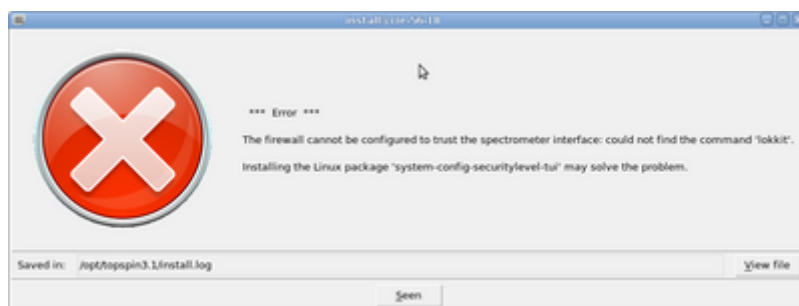
L'execució del *script* per configurar el firewall dona un error perquè no troba el programa *lokkit*

The firewall cannot be configured to trust the spectrometer interface:  
could\  
not find the command 'lokit'.

En altres paraules, és una aplicació obsoleta que no es troba ni a Debian ni a les versions més recents de Red Hat Linux.

Installing the Linux package 'system-config-securitylevel-tui' may solve the problem.

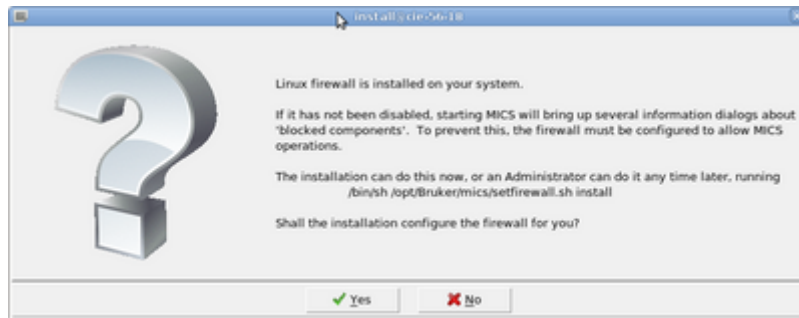
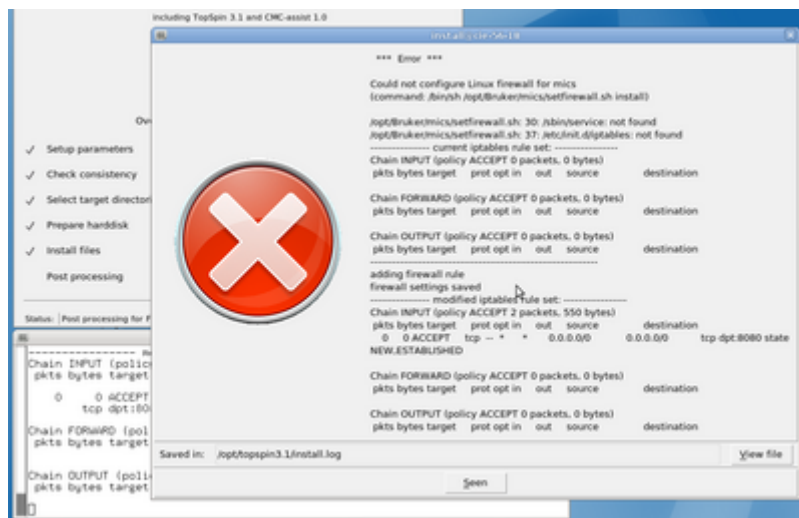
Could not configure Linux firewall for mics  
(command: /bin/sh /opt/Bruker/mics/setfirewall.sh install)

Pel que fa a l'error **/sbin/service: not found**, cal comprovar si `/usr/sbin/service` és la comanda equivalent a Debian, i si ho és, caldrà modificar el script `/opt/Bruker/mics/setfirewall.sh` perquè el faci servir.

Pel que fa a l'error **/etc/init.d/iptables: not found**, no sembla que Debian tingui cap fitxer per gestionar la posada en marxa i aturada del dimoni de firewall. He de consultar la documentació sobre iptables específica de Debian per veure quina seria la comanda equivalent.

En qualsevol cas, si es confirma que no necessitem el MICS pel nostre espectròmetre, la resolució d'aquest error deixarà de ser prioritària.

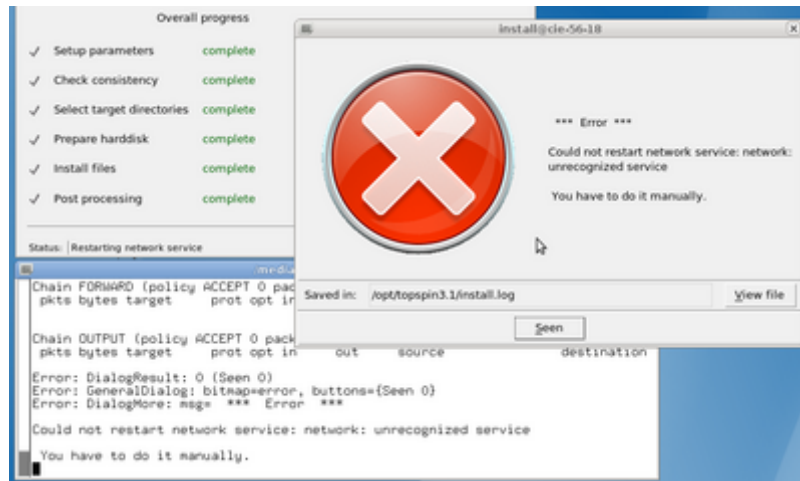
Les diferències entre les distribucions Red Hat i Debian fan que el programa d'instal·lació no aconsegueixi reiniciar el dispositiu de xarxa per la connexió a la consola.

Could not restart network service: network: unrecognized service

1. comprovar si el programa d'instal·lació ha editat correctament els fitxers de configuració;
2. reiniciar de forma manual el dispositiu de xarxa per la connexió amb la consola, i verificar que funciona.
3. Un cop trobada la solució, s'haurà d'adaptar el programa d'instal·lació per tal que funcioni amb Debian.

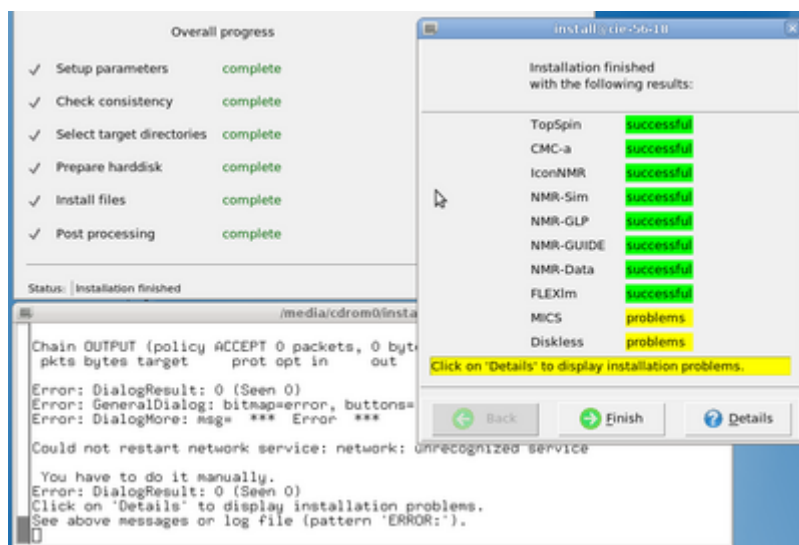
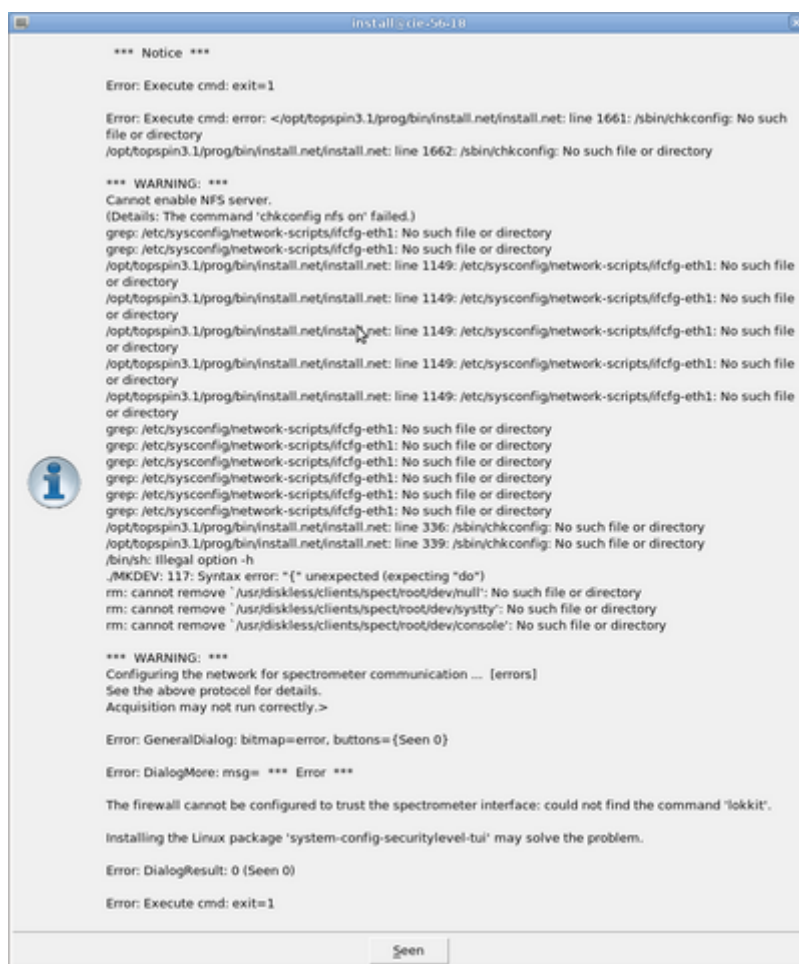
Amb això arribem al final de la instal·lació, on se'ns indica que hi ha hagut problemes amb la instal·lació dels mòduls:

indica que la major part dels errors són deguts a diferències entre distribucions (Red Hat vs Debian) pel que fa a la ubicació dels fitxers de configuració i/o els programes de gestió emprats.

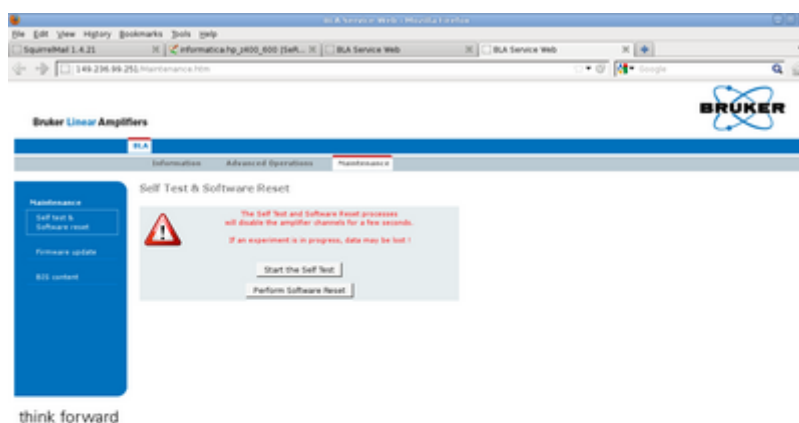
i no sembla que hagi estat una bona idea, perquè ara no puc connectar-me via pàgina web.

Aturo i torno a posar en marxa l'amplificador i a la pantalla del Wireshark veig un munt de paquets amb una nova adreça IP "149.236.99.92", llavors em connecto a la nova adreça via HTTP i em surt la pantalla de gestió de l'amplificador! Repeteixo la jugada amb l'altre amplificador i també canvia la IP,

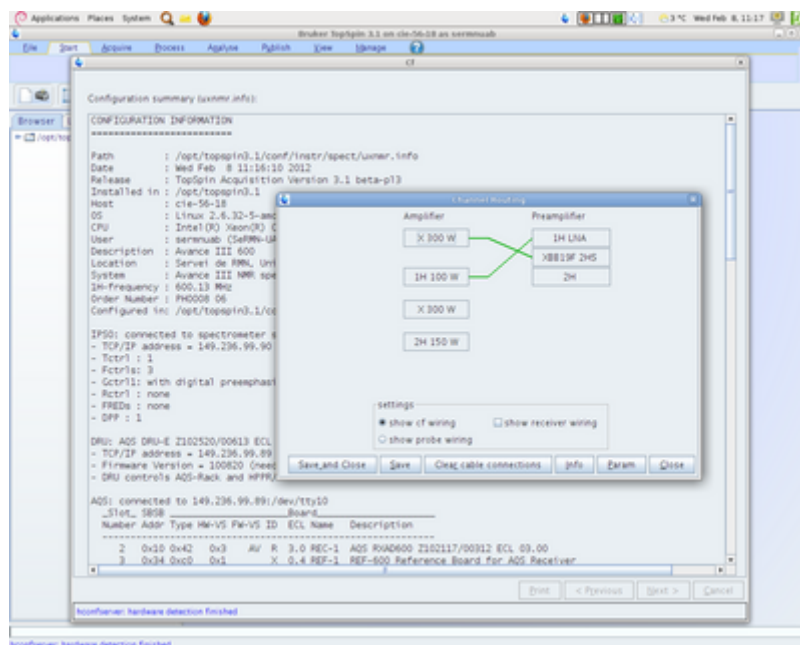
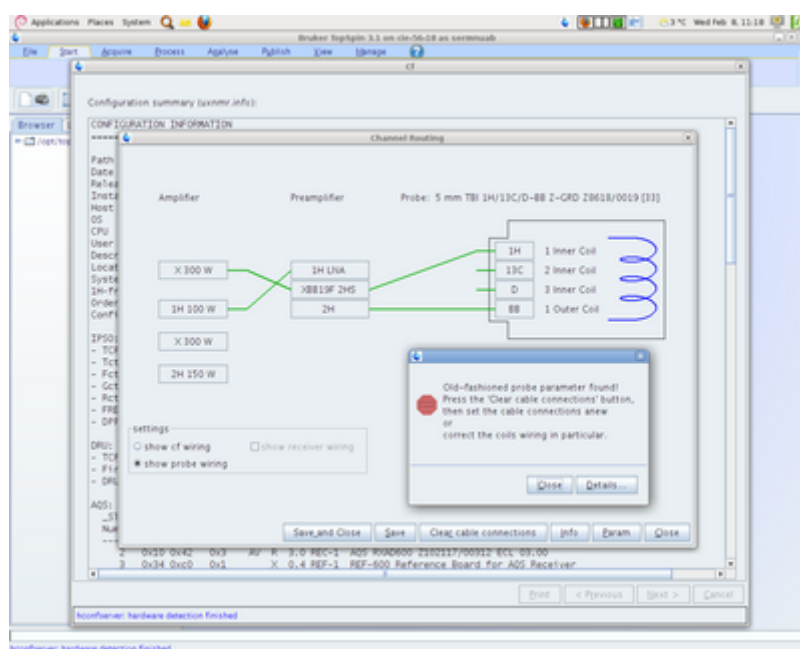
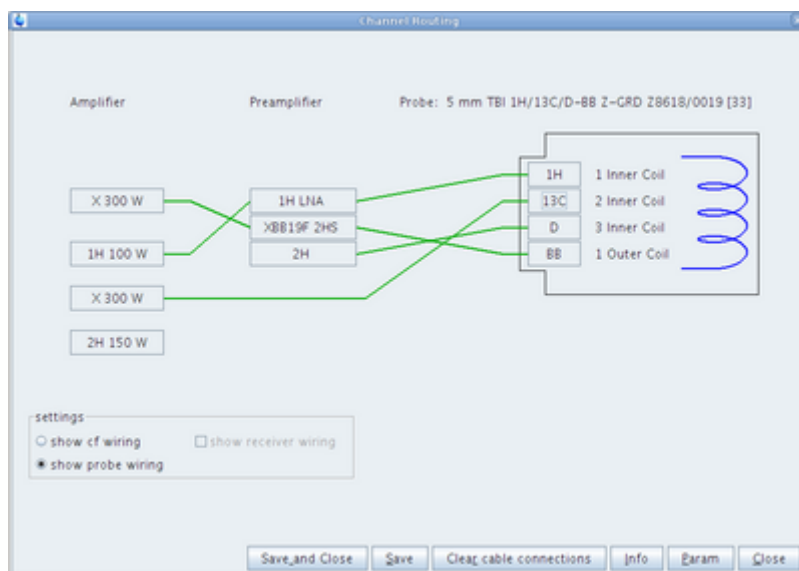
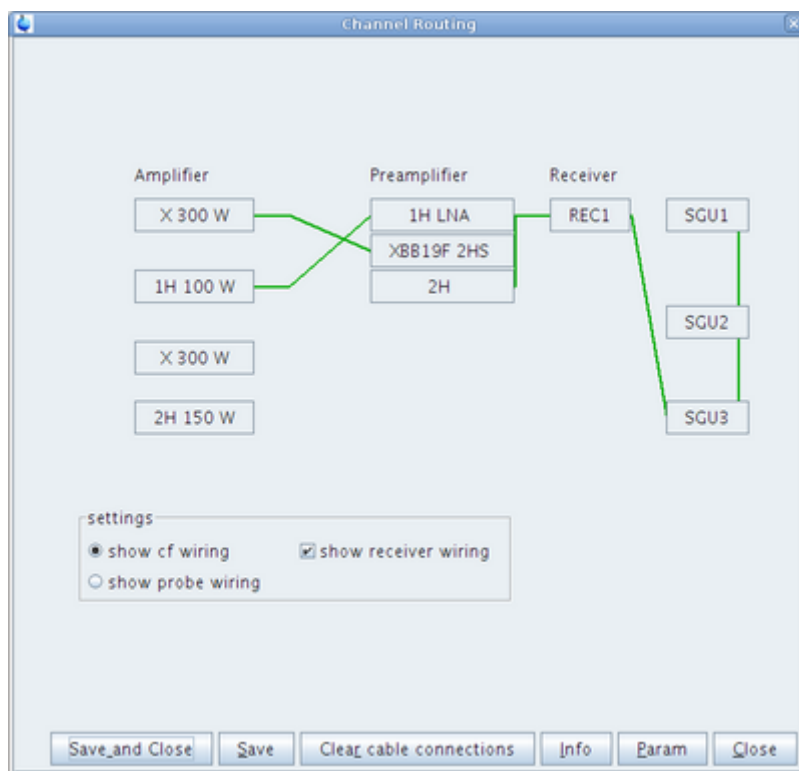
Torno a executar la comanda `cf` i aquest cop arriba fins al final i em mostra les connexions amb la sonda, però surt un missatge d'avís indicant que la informació es incorrecte i que cal esborrar-les i definir-les de nou,

Quan intento sortir, apareix un missatge indicant que hi ha connexions incorrectament definides, i que s'esborraran en sortir.

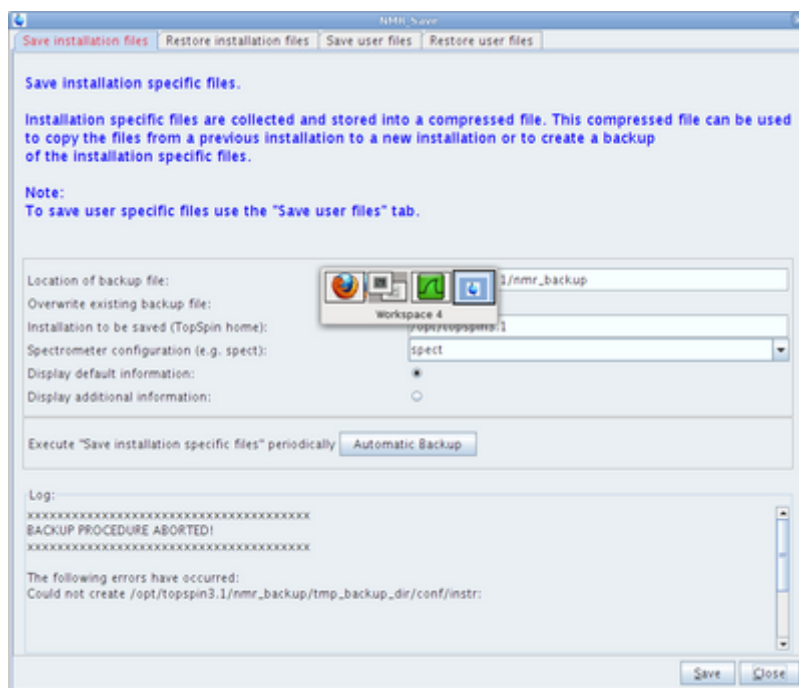
Provo a fer un primer backup i em dóna un error,

perquè no pot crear la carpeta `/opt/topspin3.1/nmr_backup/tmp_backup_dir/conf/instr`, de forma que la creo a mà,

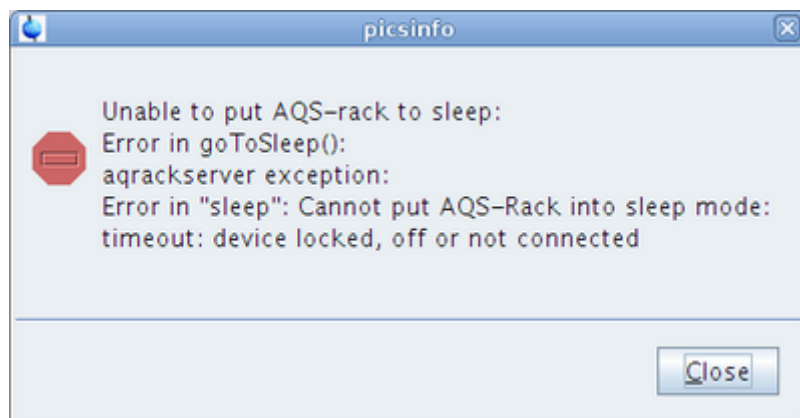
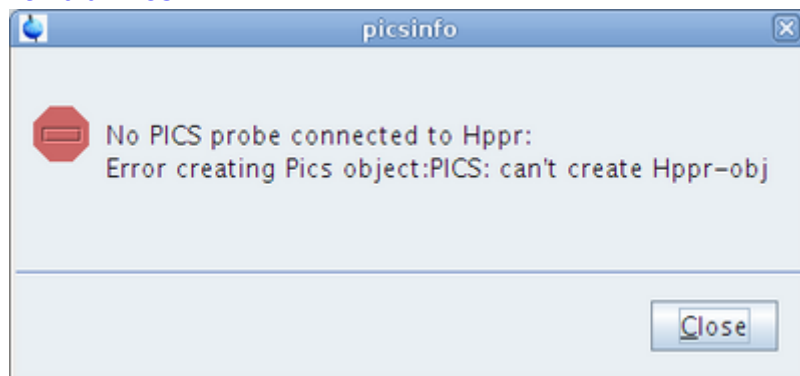
Provo a executar la comanda *edhead* amb la sonda triple-inversa, però em dona errors, primer amb l'AQS

i després amb la connexió al PICS

Però quan surto, torna a aparèixer l'error de connexió amb el PICS.

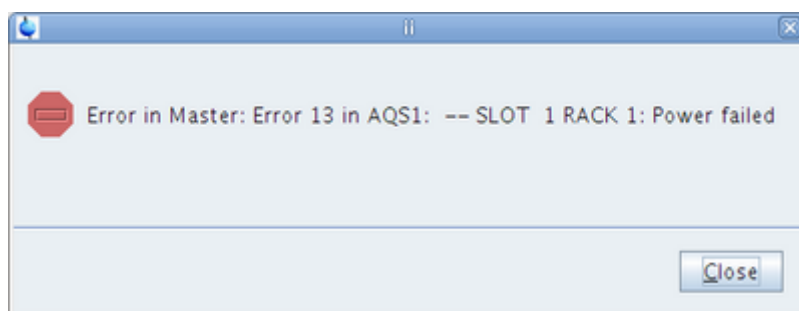
Aquest missatge d'avís és més empipador, ja que suposadament indica que la placa de la DRU al Slot-1 de l'AQS no està en funcionament. Tanmateix la placa sí que funciona, però dóna errors i timeouts, per exemple, quan s'executa la comanda `edhead` (veure més amunt).

- 1) Wait until 'cf' is finished!
- 2) Start Mozilla Web browser and enter the URL 'http://149.236.99.89'
- 3) Click 'AQS Firmware Setup' -> 'Program new DRU firmware'
- 4) Browse to '/opt/topspin3.1/conf/instr/servtool/dru'
- 5) Select the file 'dru\_firmware\_111024.gz and install the firmware.
- 6) Before starting any acquisition you must execute 'ii' in TopSpin!

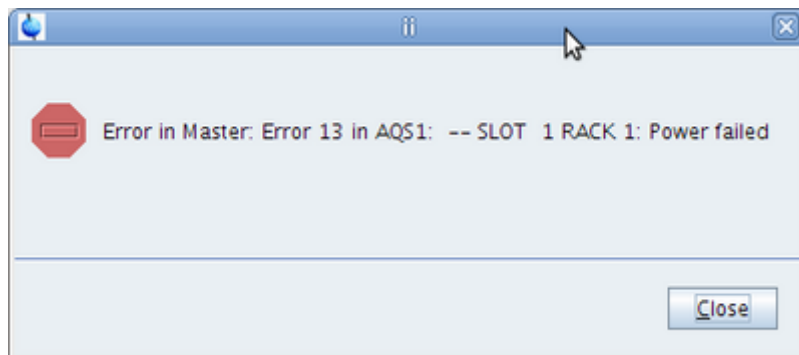
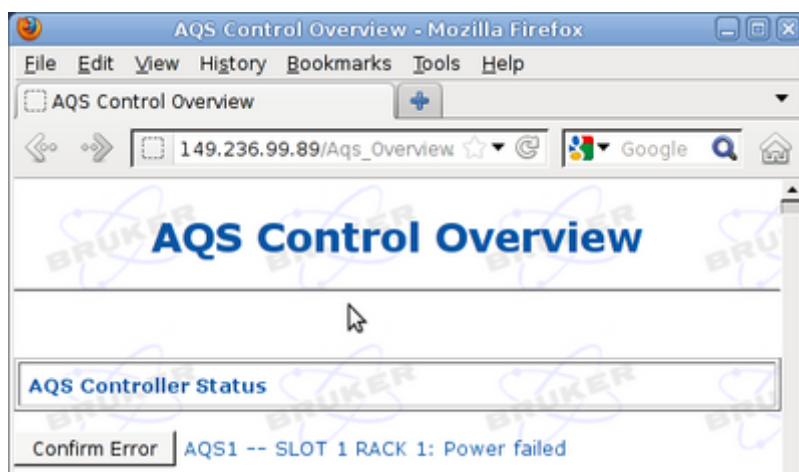
però continua sortint el missatge d'error,

que també apareix al programa de gestió de la DRU,

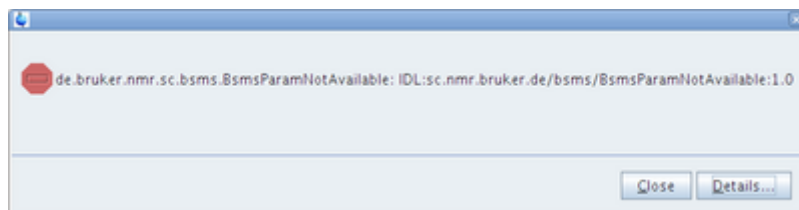
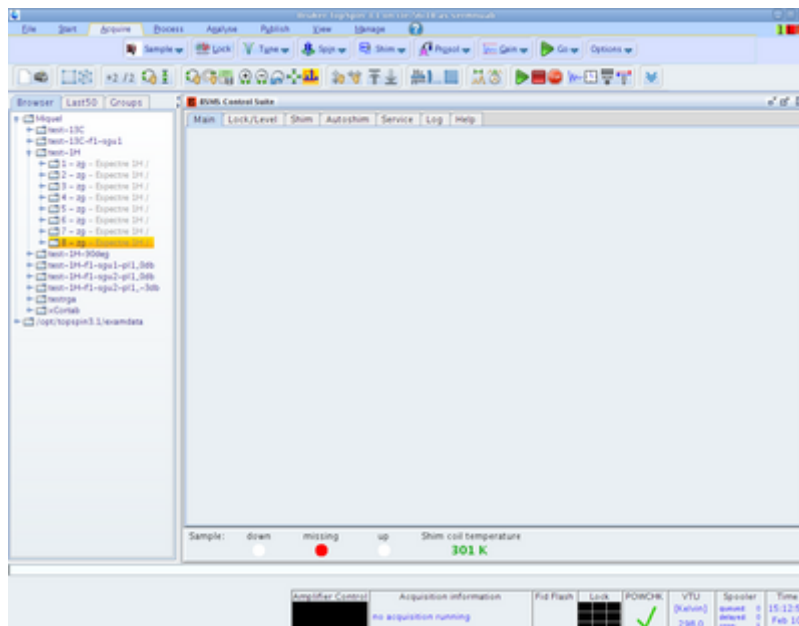
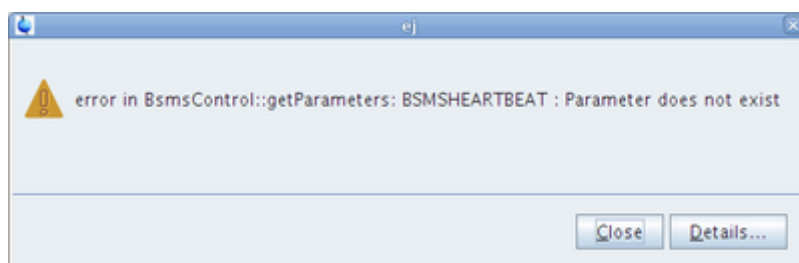
Quan hem decideixo a fer una primera prova i obro el *BMSM Panel* em dona un error,

i a la finestra *Main* no surt res,

I quan provo directament la comanda ej tampoc funciona i dóna un error,

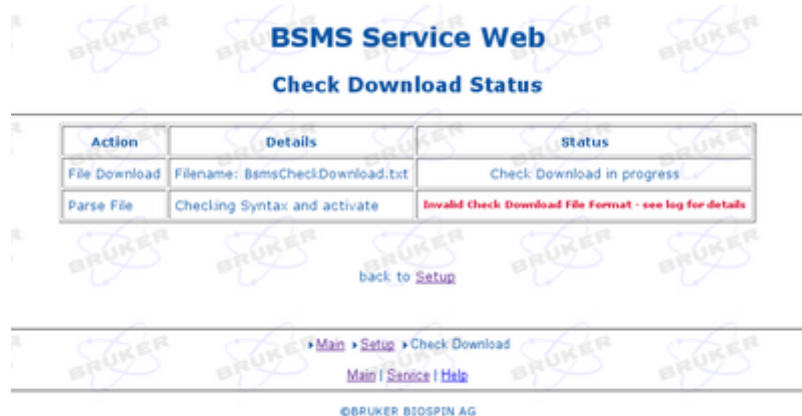
per comprovar les versions actuals i disponibles del firmware per les diferents plaques de la BSMS, em dona l'error,

```
2012/02/14 14:45:53.677660 ERROR : CheckDownload aborted - Hardware Code  
"L19F_HW_CODE" not found (Line 22)  
2012/02/14 14:45:53.713071 CORBA<- :  
BsmsStatusClient[Keyboard]::SendErrorMessage: - ok  
2012/02/14 14:45:53.717749 CORBA<- : BsmsStatusClient[TopSpin

Faig una consulta a n'Oscar i, per guanyar temps, després de comprovar els release notes i la base de dades de problemes (Item 9582 BSMS error when loading BsmsCheckDownload.txt of TS 3.0), decideixo fer servir el fitxer v. 110117 i...
